Craigton & Spittalhill Wind Farm

Soil and Water Constraints

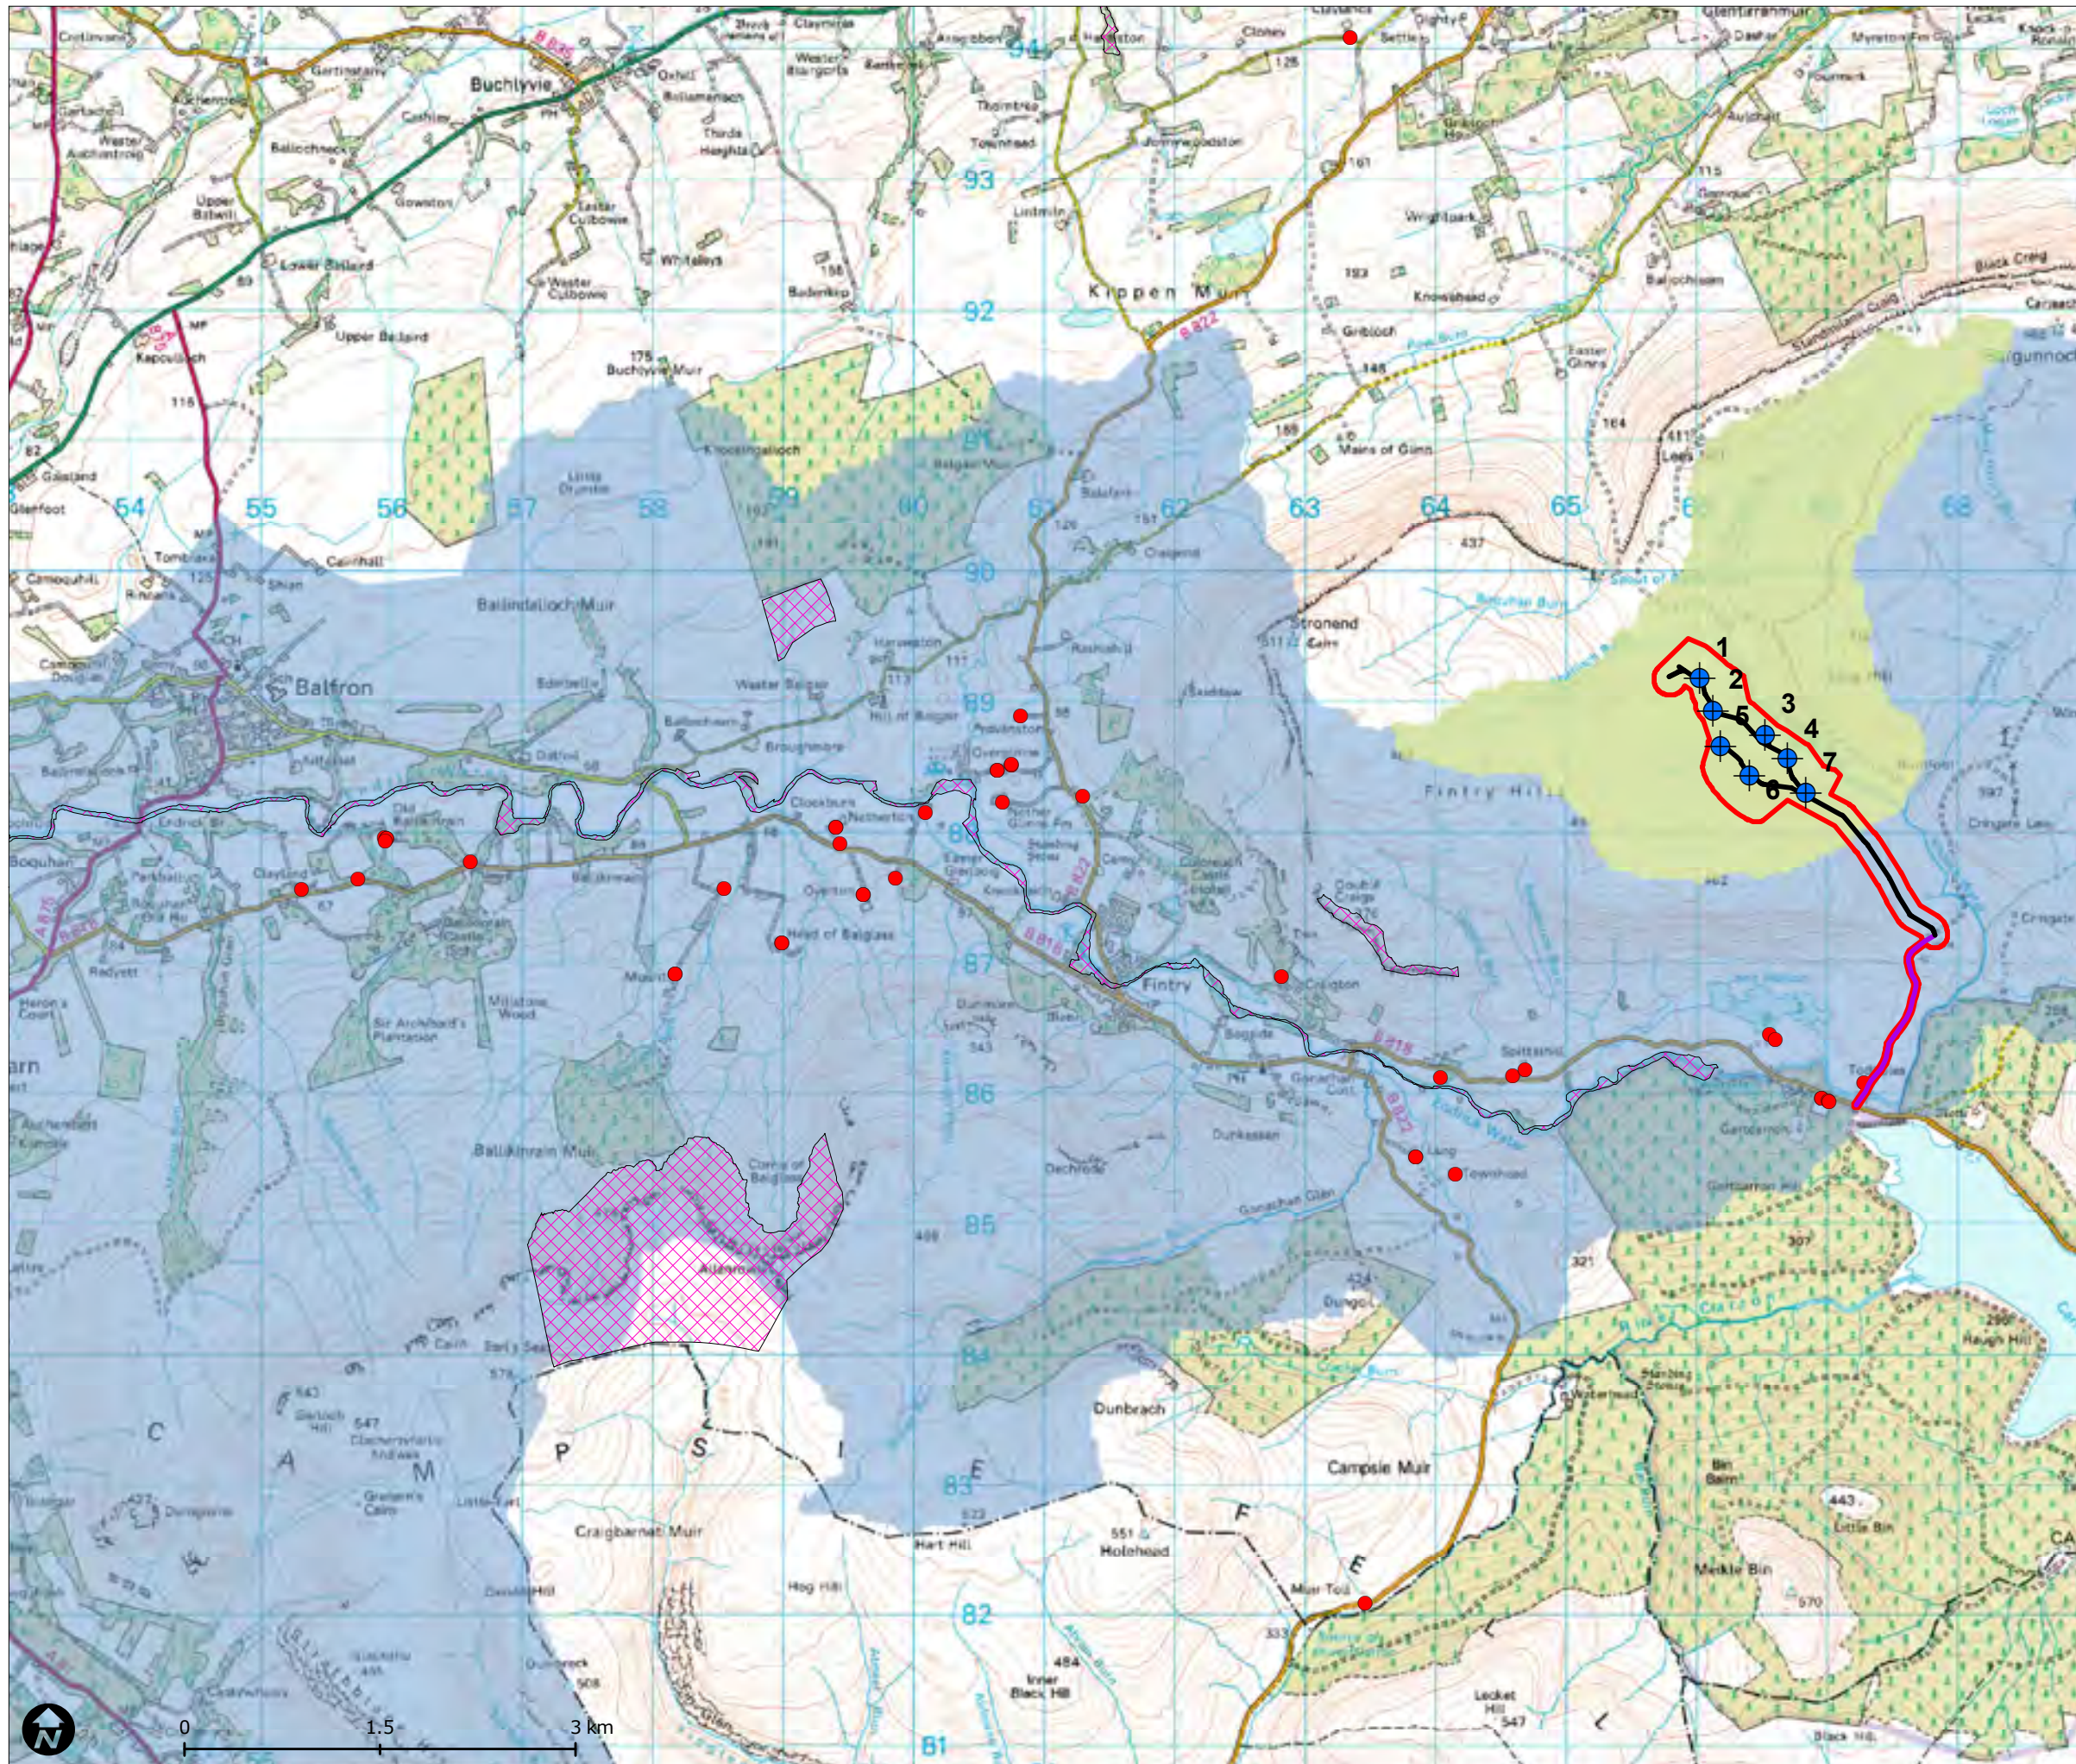
Figure 8.1

Hydrological Overview

- Catchment of Backside Burn
- Catchment of Endrick Water

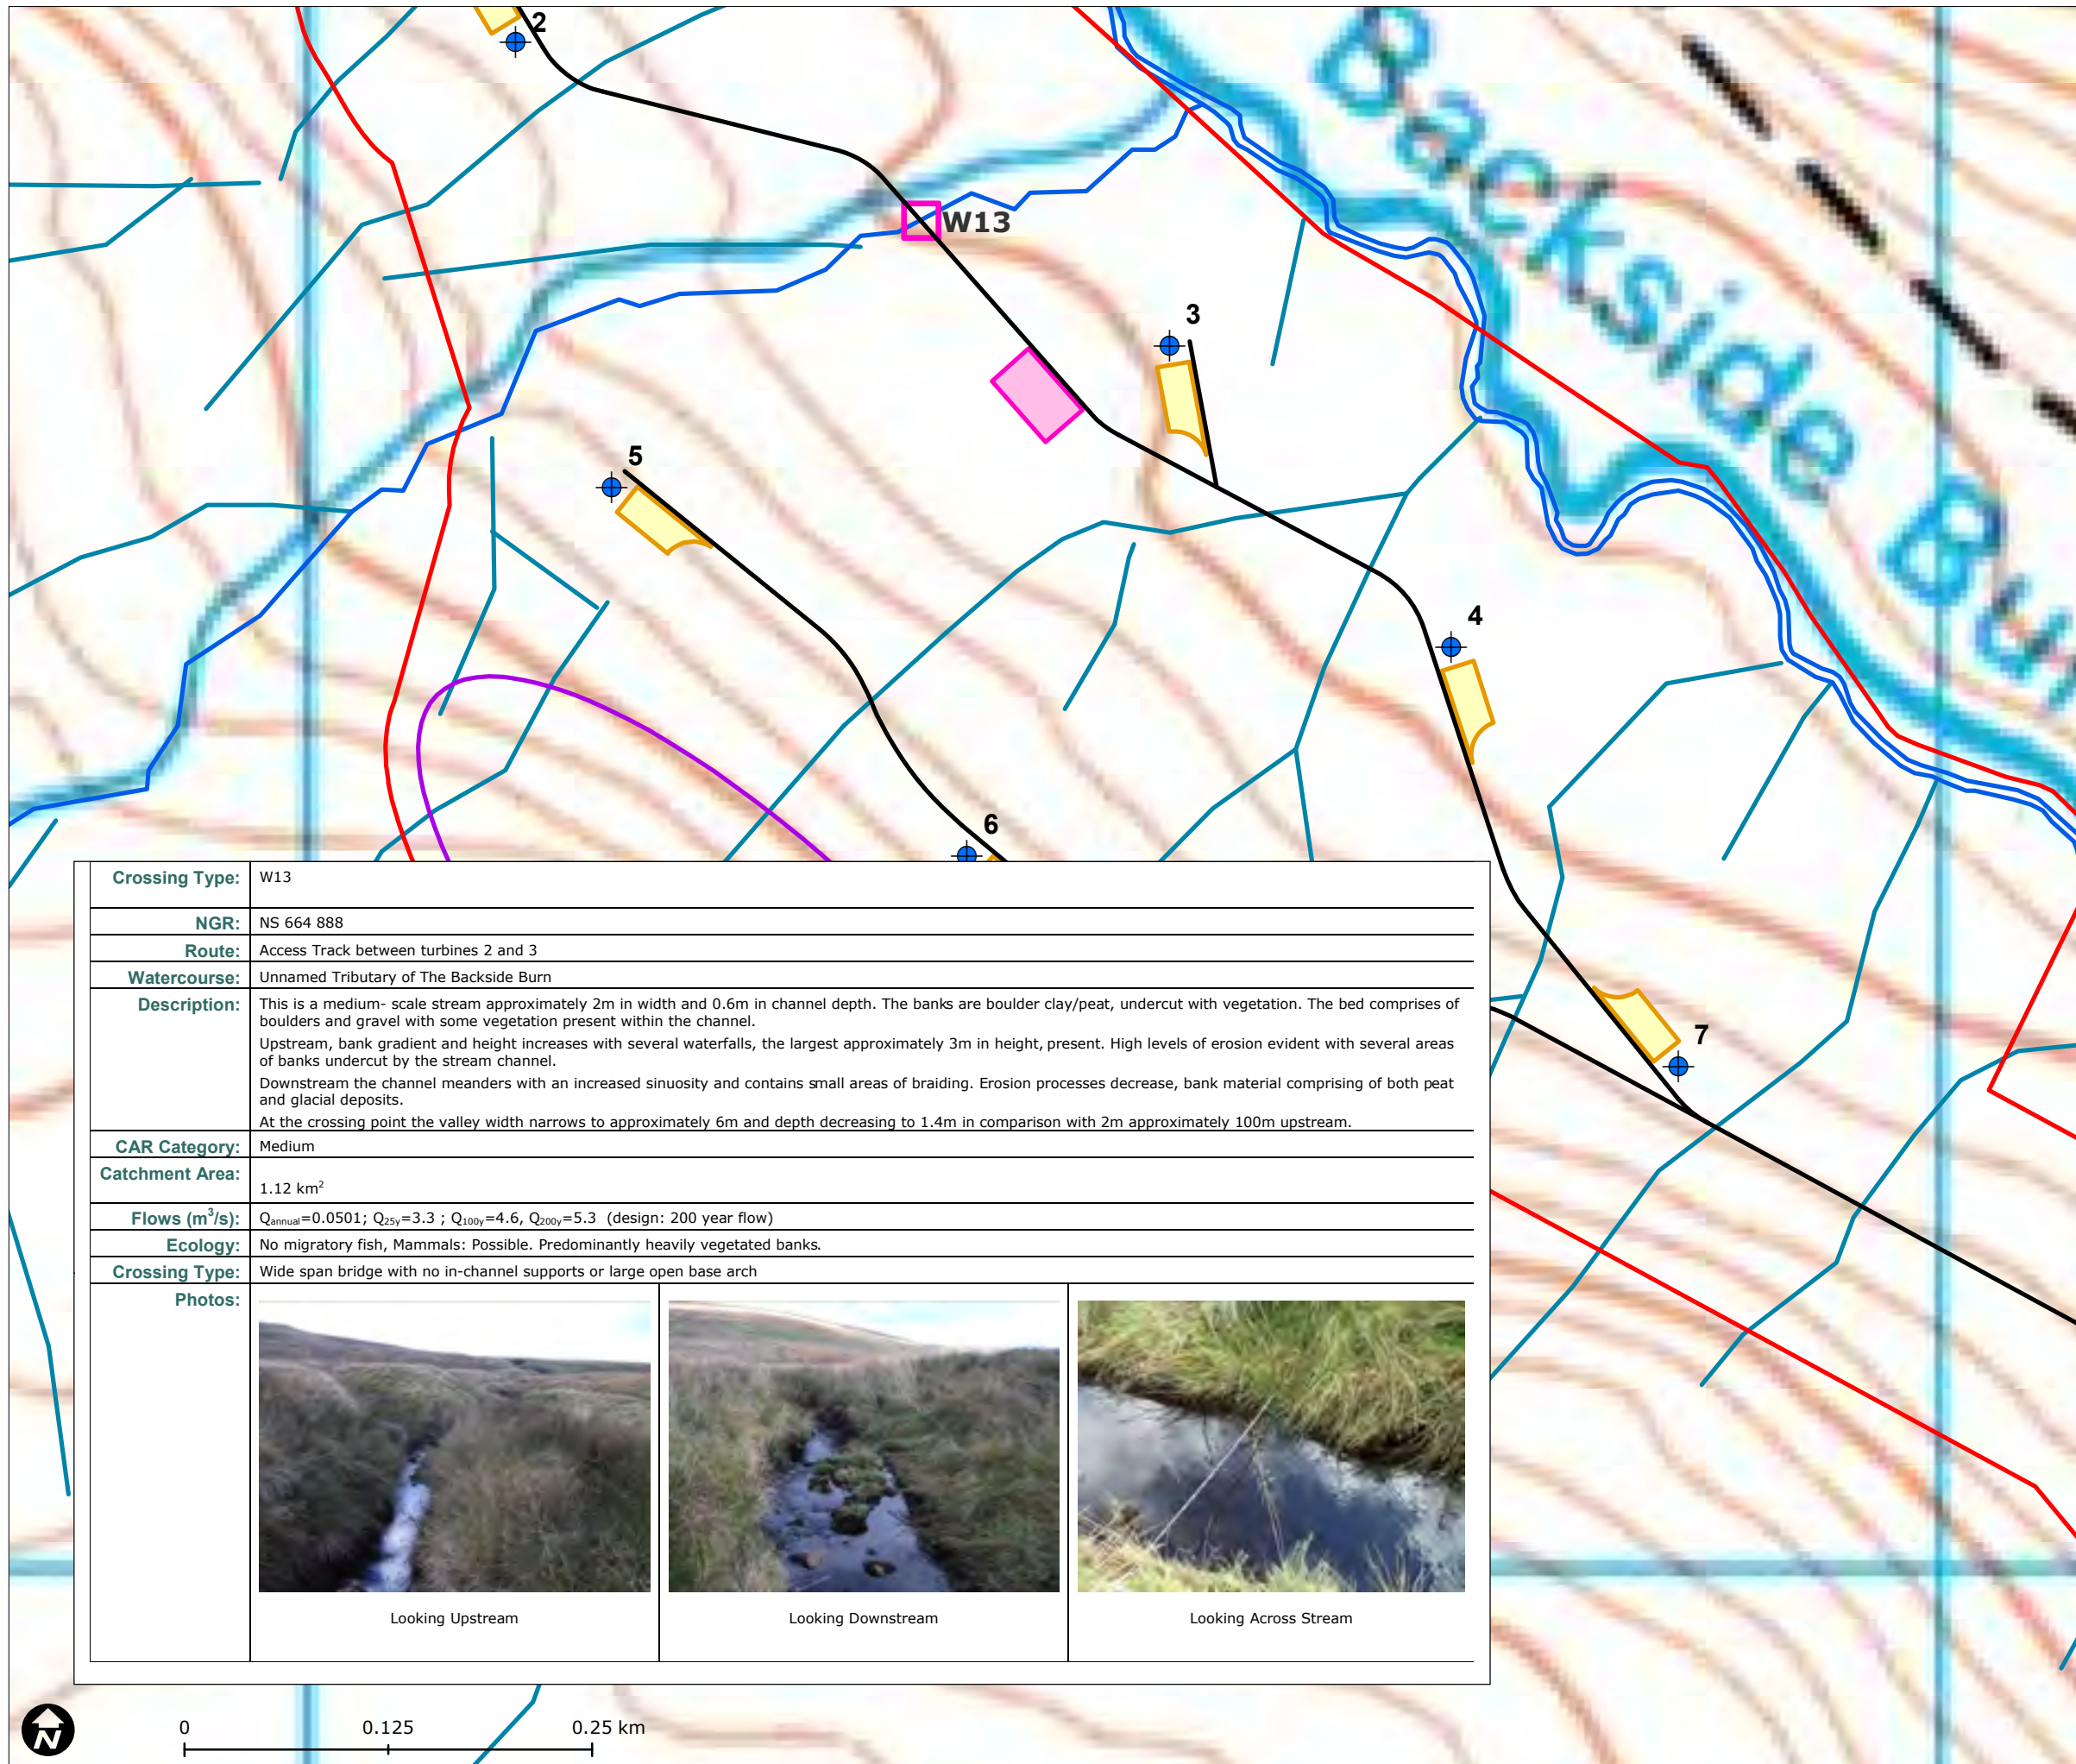
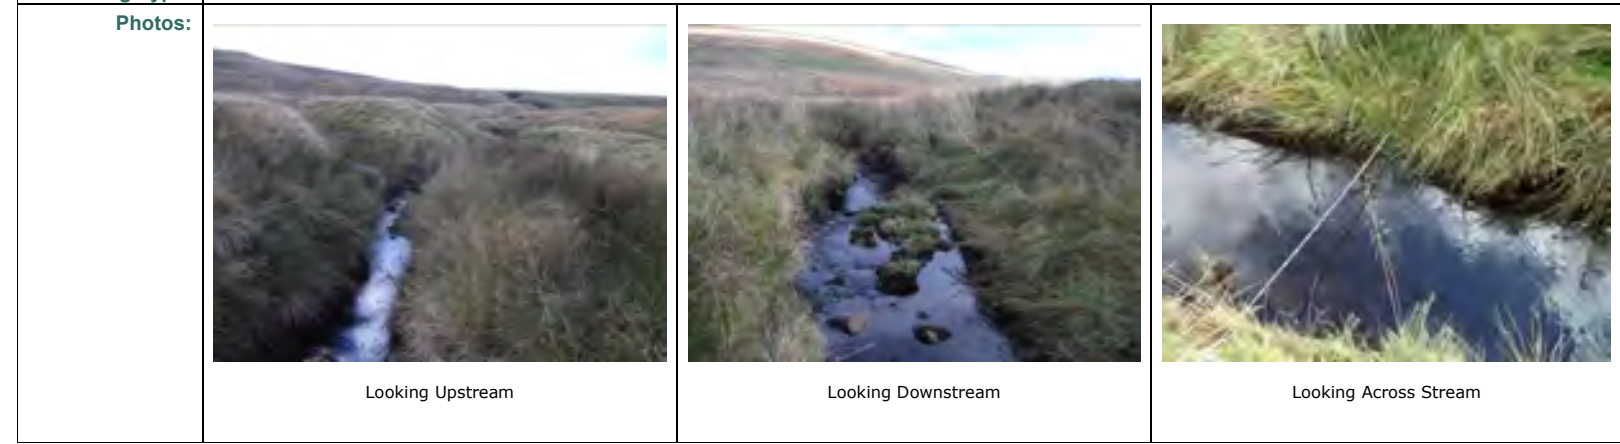
Figure 8.8

Stream Crossings (CAR)

Crossing Type:	W13
NGR:	NS 664 888
Route:	Access Track between turbines 2 and 3
Watercourse:	Unnamed Tributary of The Backside Burn
Description:	This is a medium- scale stream approximately 2m in width and 0.6m in channel depth. The banks are boulder clay/peat, undercut with vegetation. The bed comprises of boulders and gravel with some vegetation present within the channel. Upstream, bank gradient and height increases with several waterfalls, the largest approximately 3m in height, present. High levels of erosion evident with several areas of banks undercut by the stream channel. Downstream the channel meanders with an increased sinuosity and contains small areas of braiding. Erosion processes decrease, bank material comprising of both peat and glacial deposits. At the crossing point the valley width narrows to approximately 6m and depth decreasing to 1.4m in comparison with 2m approximately 100m upstream.

CAR Category:	Medium
Catchment Area:	1.12 km ²
Flows (m³/s):	Q _{annual} =0.0501; Q _{25y} =3.3 ; Q _{100y} =4.6, Q _{200y} =5.3 (design: 200 year flow)
Ecology:	No migratory fish, Mammals: Possible. Predominantly heavily vegetated banks.
Crossing Type:	Wide span bridge with no in-channel supports or large open base arch

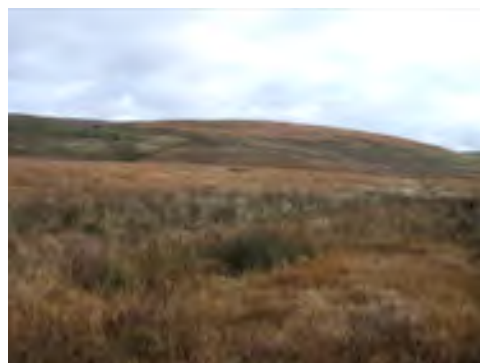
Natural Watercourses NS 661 880

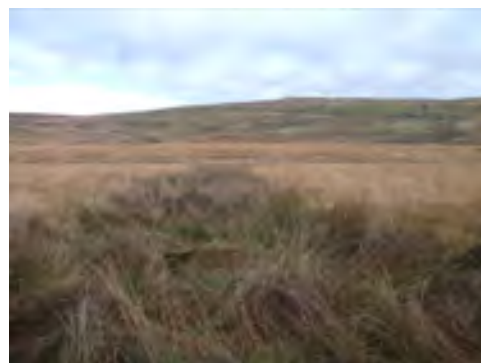
Flush Zone. Looking downstream at NS 660 891

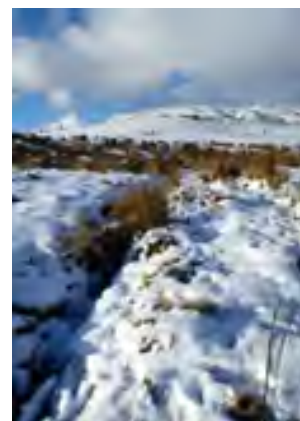
Drainage Channel Looking Upstream at NS 677 873
